Manhole Inspection Summary

Manhole # S43EE_015MH

Insp Date: **6/9/09 1:51 PM**

Location Address: **1053 BROADWAY ST**

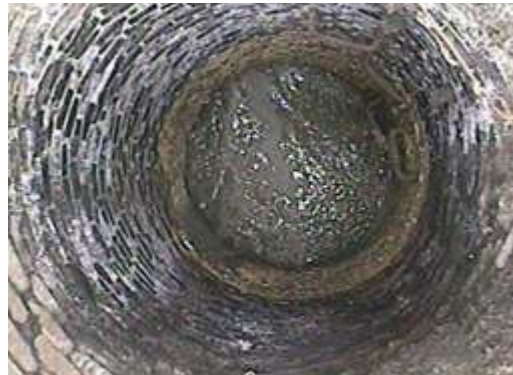
Top View

AGGREGATE SHOWING IN BARREL

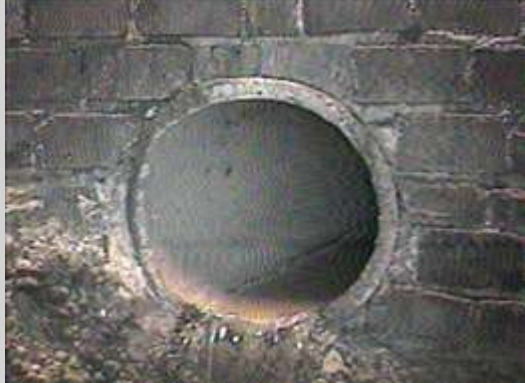
9 O'Clock Inflow

8 in. Circular Gravity Sewer

Pipe In @ 9 O'Clock

Pipe Material: **Clay** ☐ Pipe Lined

Infiltration: **None** Pipe Seal Cond: **Sound**
